Rocky Flats Environmental Technology Site

# Building 776/777 2<sup>nd</sup> Floor Final Survey Report

**Survey Unit:  
776037**

October 2004

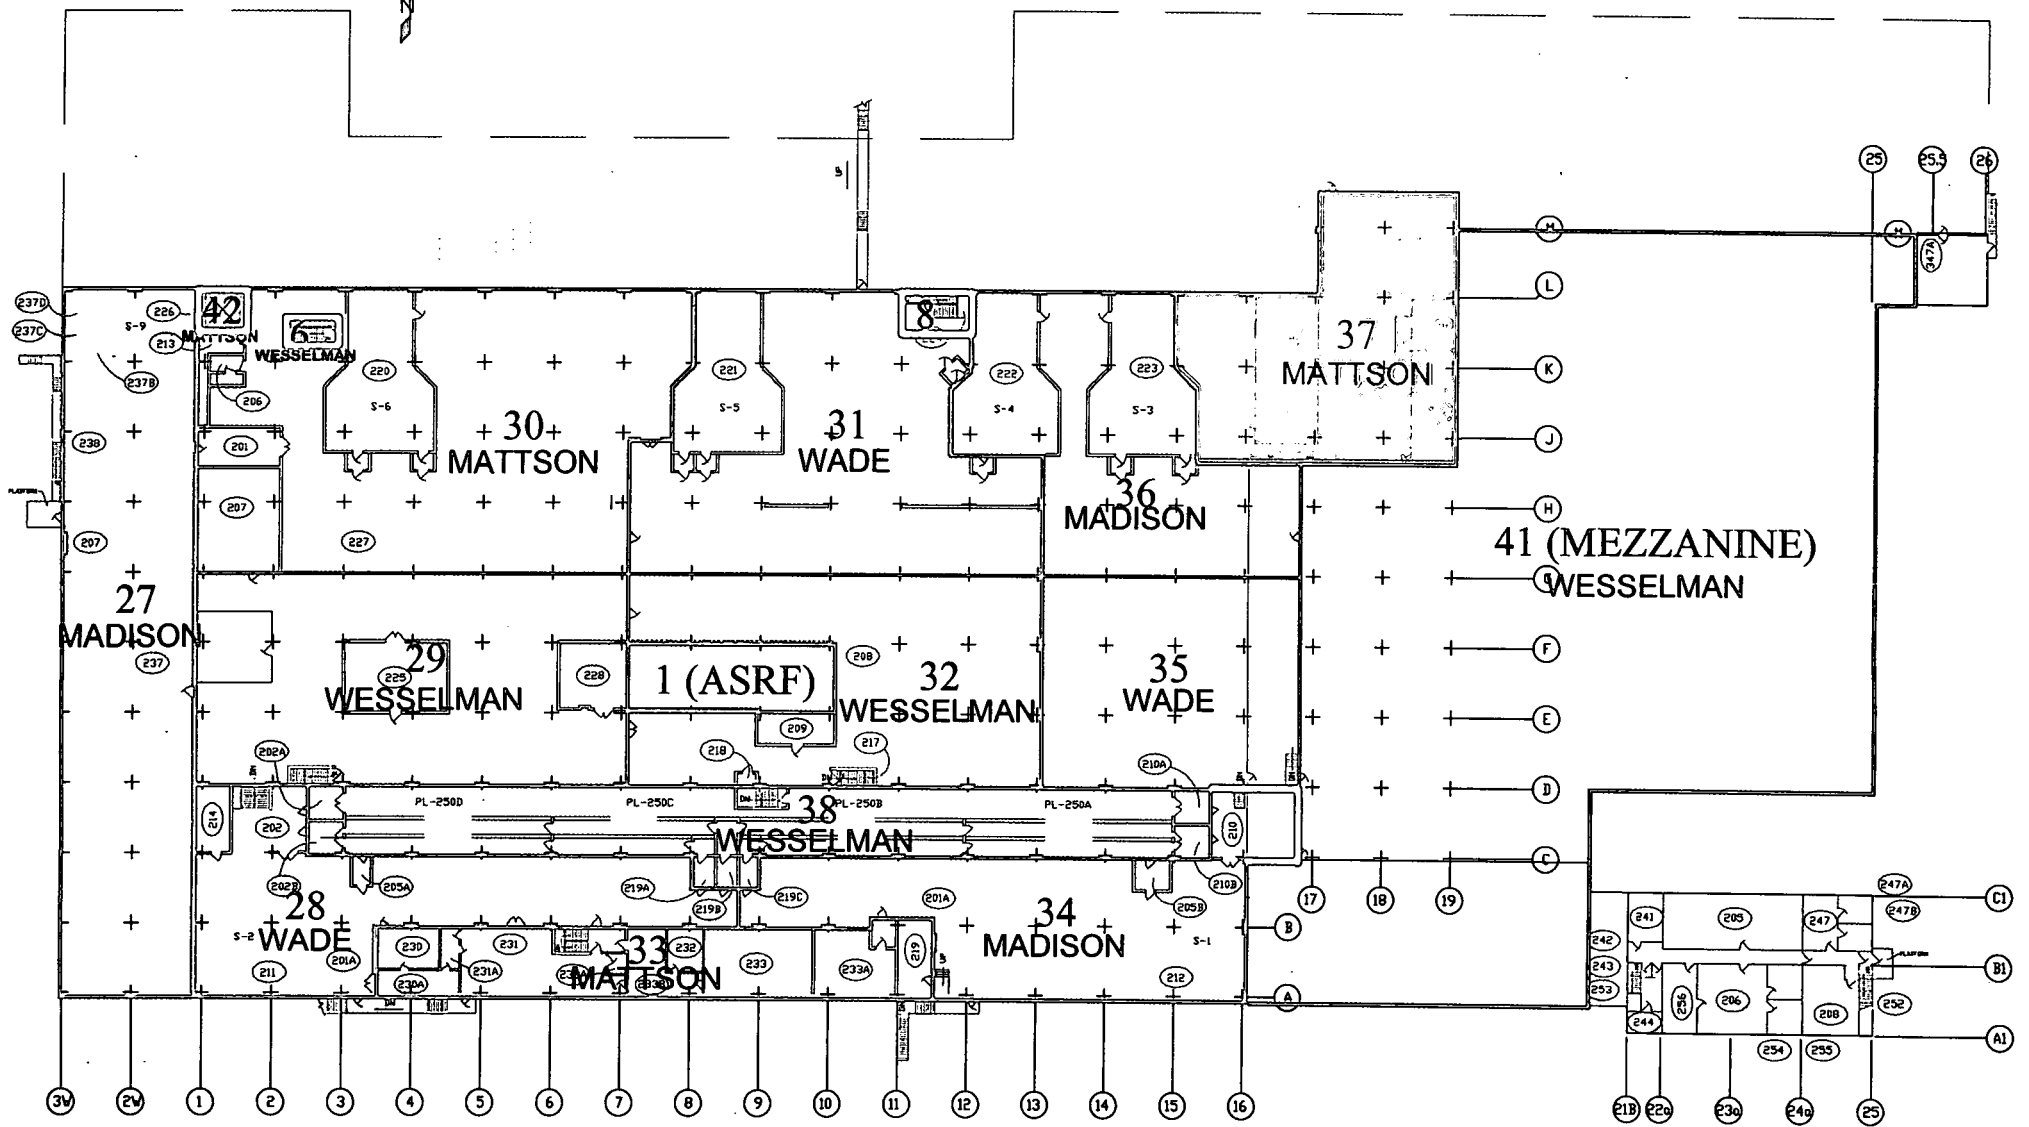
B776/777 INITIAL SURVEY UNITS  
2nd FLOOR

Survey unit 776037 is bounded by column lines 15-19 and H-N. This area is part of the original building and is located in the northeast corner of room 208, including rooms 235, 235A, 236 and 239 on the second floor of building 776.
